Damaged Insulation Mimicked Symptoms of Occipital Stimulator Lead Migration

Collin Clarke, MD, Parinaz Azari, MD, Billy Huh, MD, PhD

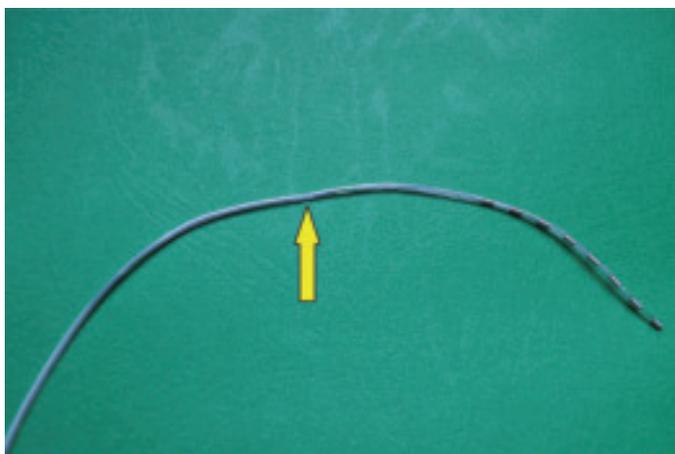
left sided stimulation. The patient continued to report excellent pain relief from her right sided stimulation. Coinciding with analgesic failure was the onset of intermittent left posterior neck triangle muscle spasm and associated burning sensations. Interrogation of the device did not show any alteration to impedance, with the range being from 427 to 557 Ohms. Stimulation settings were 00+–+00, frequency 120 Hz, pulse width 280 μsec. Plain film X-ray of the lead sites did not demonstrate any significant migration of the lead from the original positioning. In light of the patient's symptoms the decision was made to optimize lead placement via revision. Following informed consent, the surgery was performed under combination of local anesthesia and intravenous sedation with the patient in prone position with the head slightly flexed. Following dissection through the previous anchor site, fluoroscopy guidance was utilized to isolate the left occipital lead (Octrode® 3181, St. Jude Medical, Plano, TX, USA). The lead had been anchored directly with a 2–0 silk suture to fascia in a similar manner to securing a chest tube. This had been a technique chosen in patients with thin cutaneous layers to decrease the bulk of the anchor site. The lead was removed and inspected. It was observed that the insulation at the anchor site had eroded, completely exposing the internal conducting wire (Figs. 1 and 2). A new occipital lead of the same model (Octrode 3181) was

Figure 1. The Octrode lead with arrow demonstrating the point of insulation erosion exposing the internal wires.

Discussion: Disruption of occipital nerve stimulator lead insulation may mimic lead migration with failure of neuromodulation, spasm, and local burning sensations. Prior to reimplanting, a lead should be thoroughly inspected to ensure there is no mechanical failure. Anchoring should be performed with gentle direct suturing or the use of a protective anchoring device.

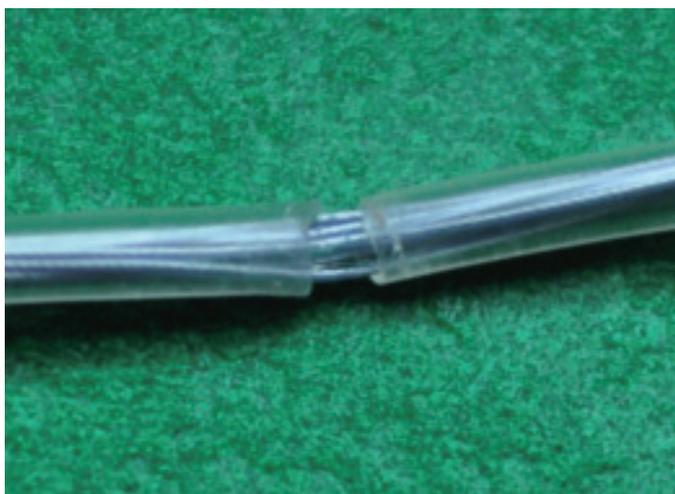
Figure 2. Close up view of the exposed internal wires at the site of insulation disruption.
