# Revision of a Superficially Migrated Percutaneous Occipital Nerve Stimulator Electrode Using a Minimally Invasive Technique

**Objective.** Percutaneous techniques for occipital nerve stimulation have been in the literature since 1999. Lead migration continues to be the most common complication to the technique. The authors would like to introduce a new technique for revision of a superficially migrated occipital nerve stimulator electrode. **Materials and Methods.** Technical report of initial case where revision was performed. **Results.** The patient had successful revision of his superficially migrated occipital nerve stimulator using a new percutaneous approach. He had no signs of infection and full return of prior function of the stimulator at two weeks and three-month follow-up visits. **Conclusion.** This case demonstrates a new safer technique for revision of a superficially migrated occipital nerve stimulator lead. The technique is a more direct and simple solution to a common problem in the percutaneous placement of occipital nerve stimulators.

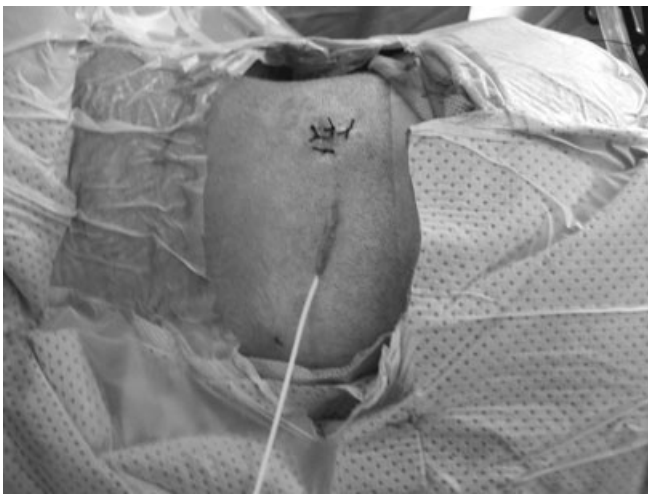
Percutaneous bilateral occipital nerve stimulators were placed in a 45-year-old man for the management of cervicogenic headaches. The stimulator had been in place for approximately one year with excellent results. The lead was placed using the percutaneous technique referenced above. The patient presented to the office with a chief complaint of a burning pain in the area of his occipital nerve electrode. This pain was only present with the stimulator on and, subsequently, the patient had stopped using the right-sided occipital stimulator. Upon further examination, it was noted that the lead had migrated superficially under the subcutaneous tissue when compared with the left-sided lead. (Fig. 1) The type of migration or displacement we are discussing in this case is superficially toward the skin surface. This is also commonly referred to as a decubitus or electrode erosion. When comparing the initial

**FIGURE 1.** Superficial erosion of occipital lead (shown at tip of white pointer).

fluoroscopic images from a year ago with a current image, there was no migration of the lead toward the proximal anchor site, which is a different type of migration. We speculated that the burning sensation was from stimulation of the superficial scar tissue. The skin around the right occiput region also was thoroughly inspected and there were no signs of infection. The patient was scheduled for a revision of the migrated scalp electrode.

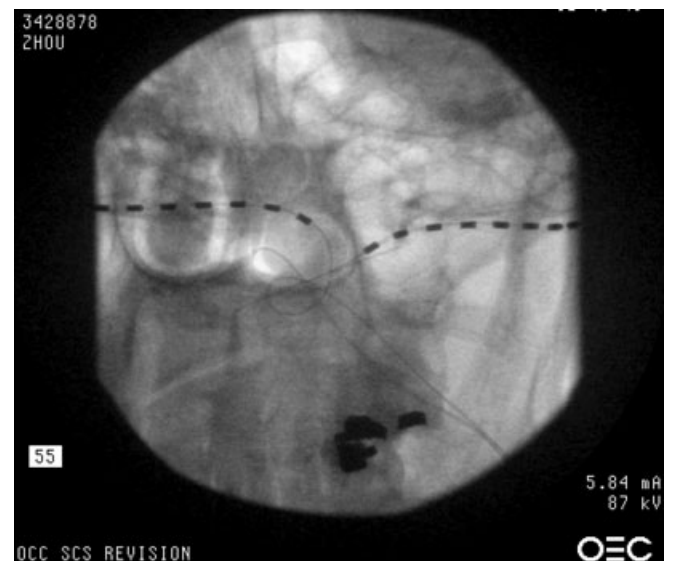
**FIGURE 2.** Initial fluoroscopic image.

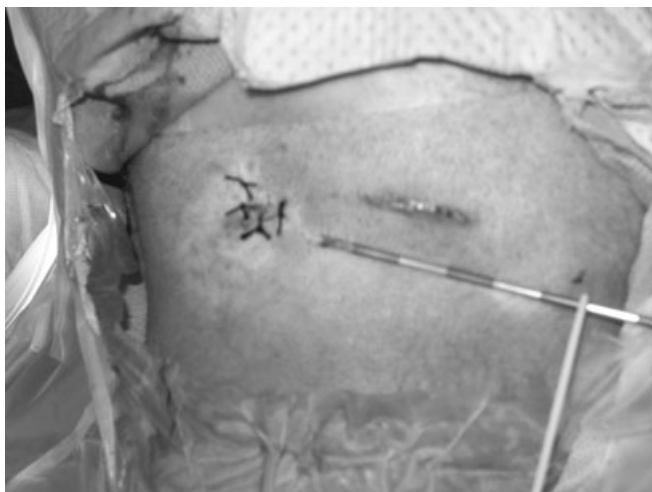
**FIGURE 3.** Demonstration of new placement of lead 1 cm below previous lead site. White pointer demonstrating lateral puncture site of Touhy needle directed toward V incision (seen with silk sutures).

Obvious damage to the lead would require replacement of the lead. In our case, the lead exhibited no gross damage. The repositioning of the lead was to be 1 cm below and parallel to the previous tract of the right-sided lead. (Fig. 3) The lead was now measured to approximate its most lateral position on this repositioned tract. A mark was made using a sterile marking pen 2 cm lateral to this lateral most point along the occiput. A 15-gauge Touhy needle was then bent concave toward the bevel to approximate the curvature of the occiput. It was then inserted, subcutaneously, from the lateral mark medially toward the midline of the occiput. The bevel of the needle was positioned deep to ensure that the end of the lead would be buried deeper in the subcutaneous tissue and not in a superficial direction. This helps to ensure that the lead will not migrate superficially. The needle was advanced in a lateral to medial direction until it was visualized through the “V” shaped incision. Care must be taken to assure that the lead is not damaged by the sharp end of the Touhy needle. The stylet was then removed from the hollow Touhy needle. The dissected lead was carefully threaded through the epidural needle in a medial to lateral direction. The Touhy needle was then slowly removed in a medial to lateral direction. The removal of the needle buried the lead in the parallel plane approximately 2 cm below the old tract and the lead buried in the subcutaneous tissue.

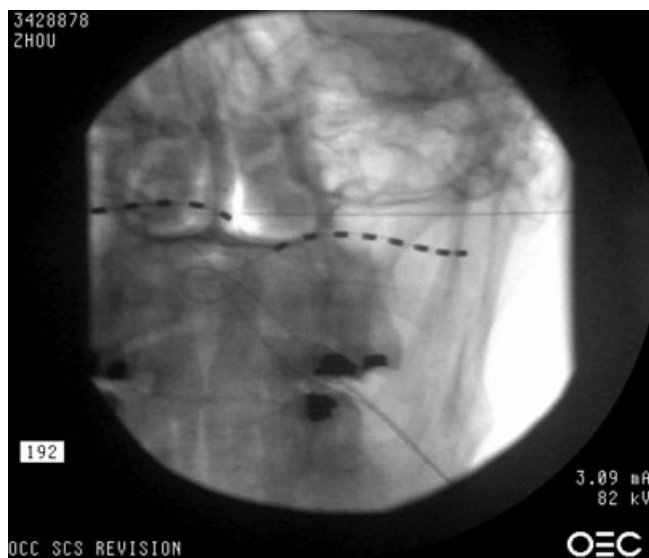
**FIGURE 4.** Fluoroscopic image after lead revision with original lead placement marked by thin needle 1 cm above new lead position.

Fluoroscopy was used to confirm position of the electrode and comparison was made to previous fluoroscopic pictures taken at the beginning of the case. (Fig. 4) The

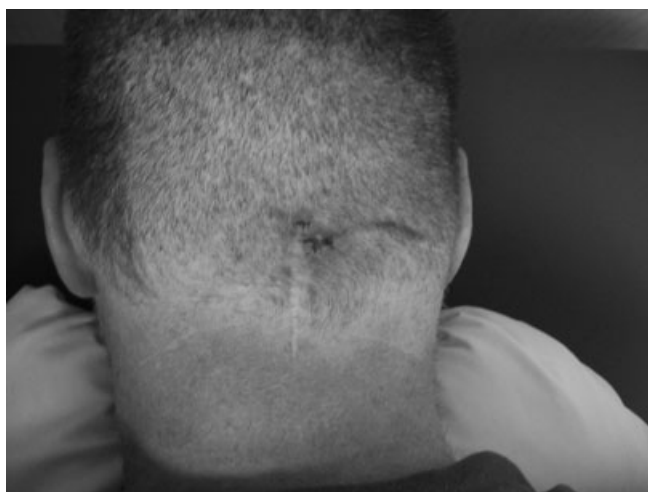
**FIGURE 5.** Ten-day follow-up in clinic after suture removal.

stimulator was then tested and confirmed by the patient to be in satisfactory working condition. The incision was closed using 3-0 silk sutures and covered with a sterile dressing. The entire procedure took about 15–20 minutes. The patient was transported to recovery and discharged shortly from the hospital. The patient was sent home with a prescription for an antibiotic for prophylactic purposes. The patient was seen in the office ten days and six months after the procedure with no complications and no signs of infection around the surgical site. (Fig. 5) His previous pain with use of the right-sided occipital stimulator was
